Test Report

Fire Resistance Test  
On  
Fire Rated Steel Double Door

Test Sponsor:  
Karachi Steel Services

Lab Report No.: FRR-1812/883 SN 1/1  
Lab Project: P - 3725  
Page No: 2 of 25

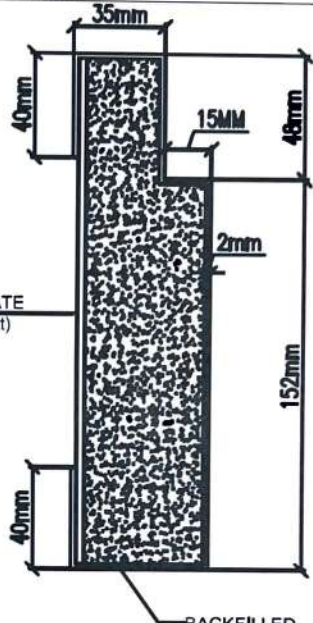
Fire Rated Steel Double Door Frame	
Overall Dimension of Frame	Height x Width: (2400 x 2400) mm
Overall Width of Jamb	200 mm
Type of Frame	Steel Hollow Frame with Cebex Cable Grout as infill
Frame Constituents	2mm thick Galvanized Iron Sheet bent to form frame outer profile
	(196 x 200) mm frame backing plate 3mm thick
	(100 x 12) mm anchor bolts, 3 on each side
Frame Dimensions

Rebate Face: 35 mm
	Frame Stop: 15 mm
	Rebate: 48 mm
	Soffit: 152 mm

Table 2.2: Steel Double Door Frame Details

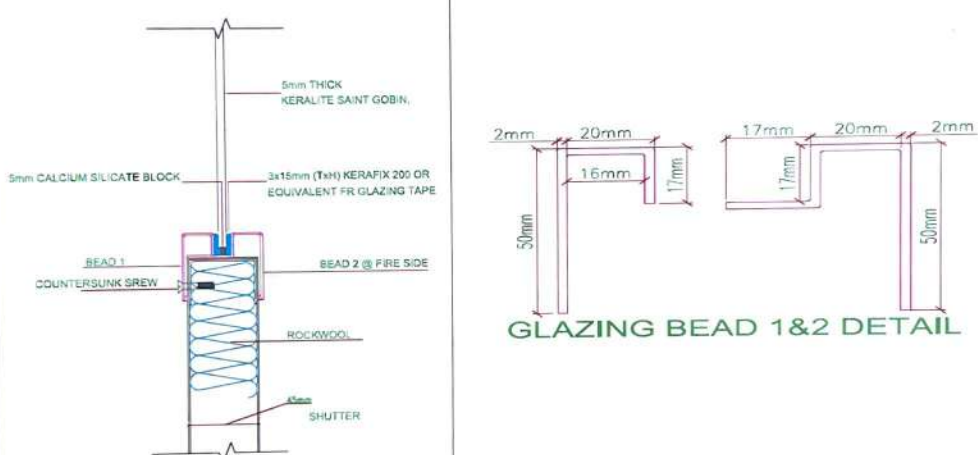
Vision Panel Details for Fire Rated Steel Double Door	
Glass Trade Name	KERALITE SAINT GOBAIN
No. of Vision Panels	2 (1 on each leaf)
Vision Panel Overall Dimensions	(255 x 350) mm
Glass Nominal Thickness	5 mm
Aperture Dimension	(200 x 300) mm
Glass Overall Dimension	(180 x 275) mm
Visible Glass Dimension	(155 x 250) mm
Glass Seal Details	3 mm Kerafix2000 glazing tape in between beading and glass and 5mm Calcium Silicate blocks on bottom of glass, 6mm air space on the upper side between glass and steel beading.
Glass Frame Detail	(50 x 20) mm, 2 mm thick channel
Glass Fixing to Frame	Steel M4 Screws, 2 on vertical and horizontal Non fire side of vision panel and screwed at 90° and welded at fire side of vision panel.

Table 2.8: Vision Panel Details

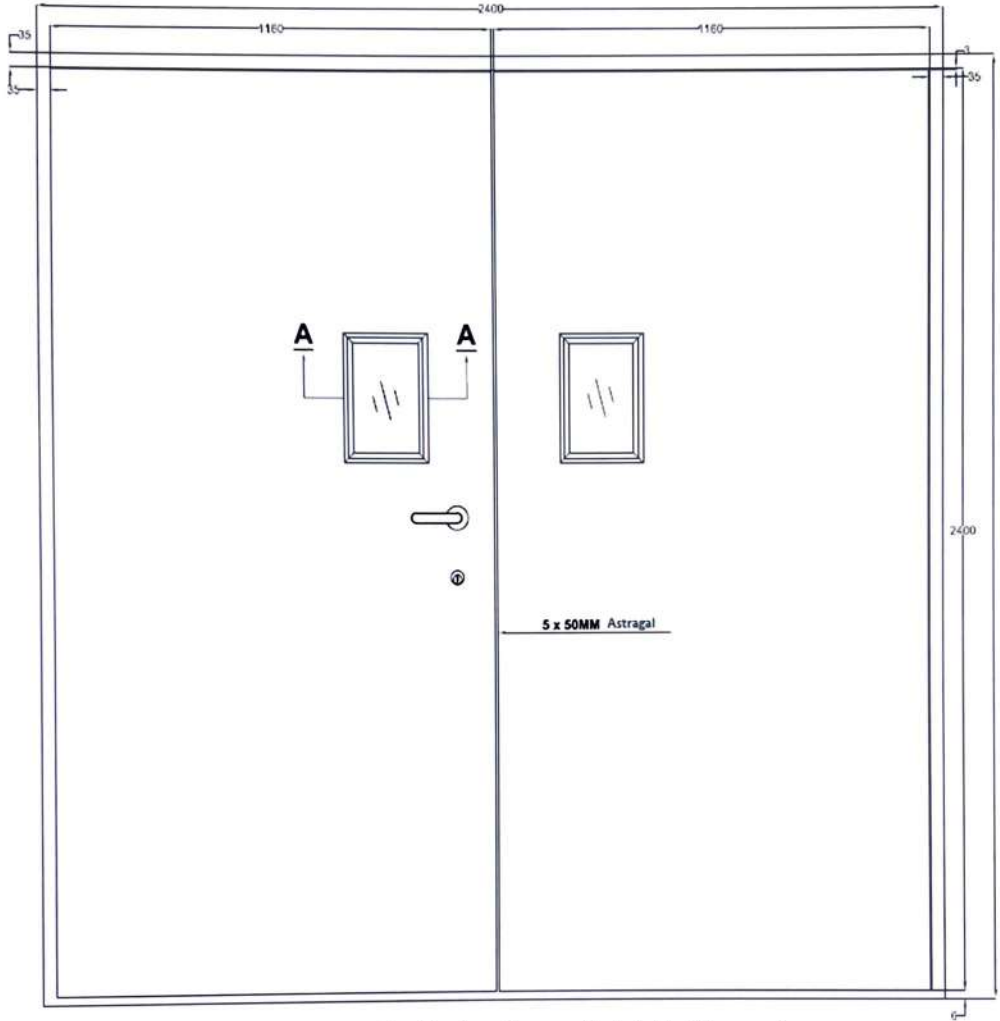
Figure 1.2: Fire side view of the assembled steel double door set

Gap at sill level between the steel door panel and the floor was approximately 6mm. Gap between the Steel double door panel and frame on fire exposed side along vertical and horizontal sides, was 3mm & 3.5mm, respectively. Gap between the steel double door panel and frame on front side, both vertical and horizontal sides, was less than 3mm. Gap at meeting stile edge between both leaves on fire and non-fire side was 3mm. Figure 1.1 to 1.5 illustrates front, side and fixing details of the completed steel door panel and frame assembly.

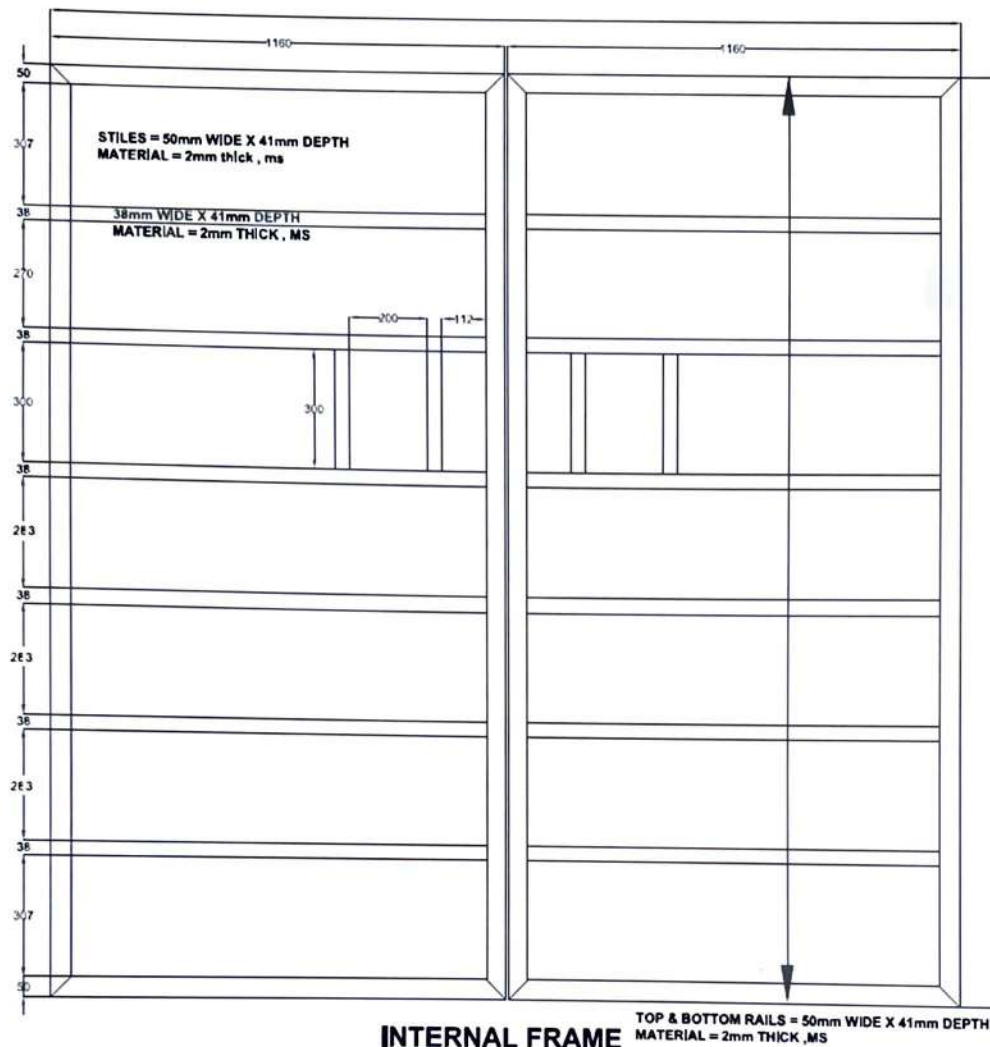
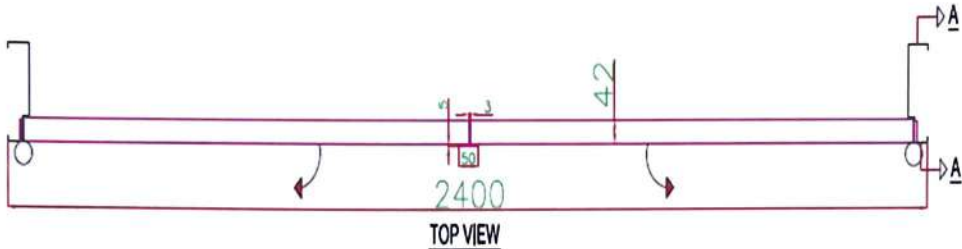
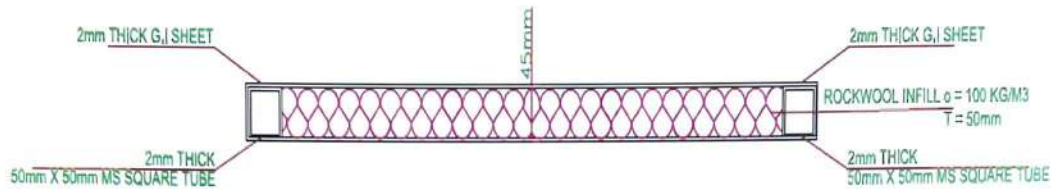
Figure 1.4: (a) Top view showing meeting stile section fixing details of assembled steel double door set, (b) Top view of section showing details of leaf of steel double door set

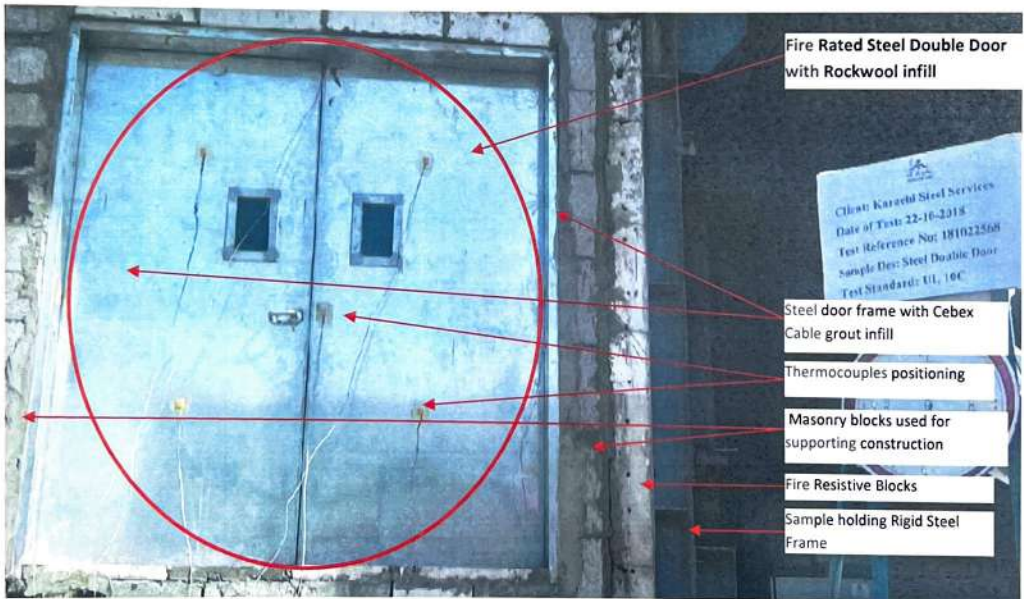
Figure 2: Test specimens mounted in frame for testing

The Steel double door was then fixed in to the supporting construction opening by the sponsor's representative. The steel double door frame was fixed to the supporting construction with expansion anchor bolts after which Cebex Cable grout was filled in to the hollow steel frame and gaps in between the frame and blocks were sealed using mortar. In accordance with ANSI/UL 10C-2009 clause 9.1, opening of the swinging double door was kept inside towards the furnace.

After fixation, the specimens were verified to be in accordance with technical drawings provided by the sponsor. Gap measurements were taken. The specimen was left in its closed position. No locks were engaged and only the lock latch bolt and flush bolts on the inactive leaf were engaged in accordance with clause 15.2 of ANSI/UL 10C-2009.

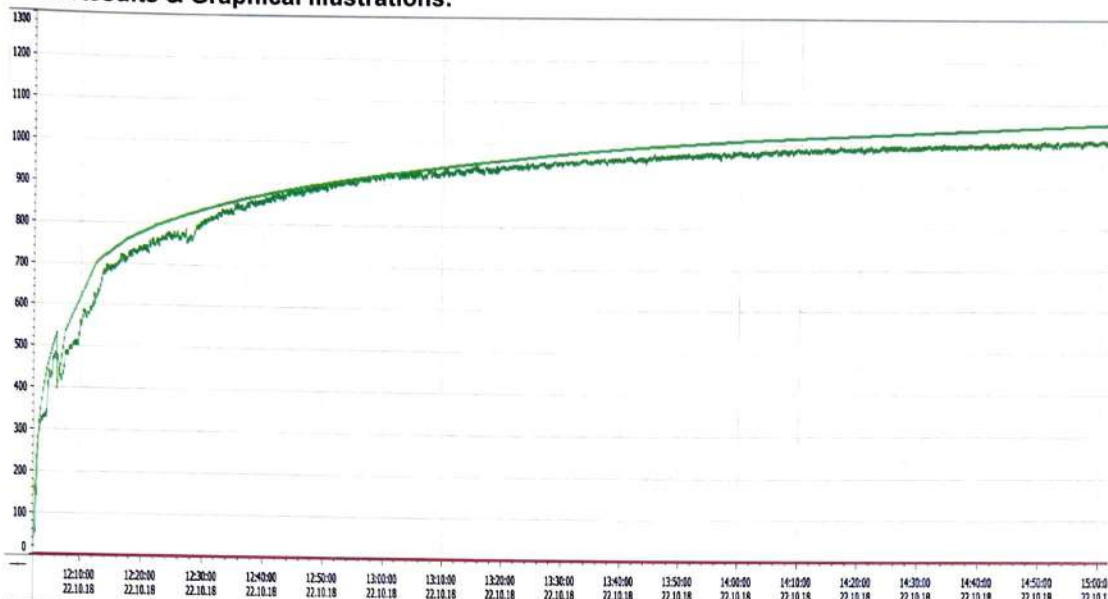
Figure 3: Average Temperature graph of internal furnace thermocouples for complete duration of the test

The fire testing engineer also ensured that the temperature inside the furnace did not deviate and remained within the tolerance limits set in clause 5.4 of ANSI/UL 10C-2009. The graph representing regulation of internal temperature of the furnace in accordance with ANSI/UL 10C-2009 has been provided in figure 3 of appendix 2.

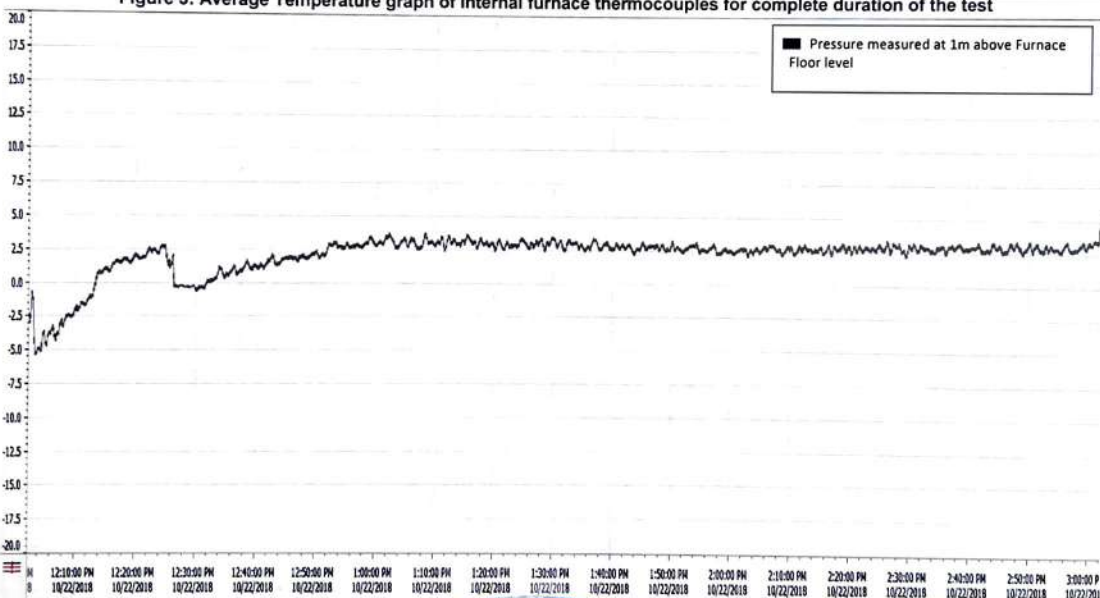
Figure 4: Furnace internal pressure graph for complete duration of the test

A trained fire testing engineer continually ensured that furnace conditions during the test, such as temperature and pressure, were kept in accordance with clause 4 and 7 of ANSI/UL 10C-2009, respectively. During the test a neutral pressure plane was set up 1m above the furnace floor and the pressure at the top of the furnace was not allowed to exceed 20 Pa.

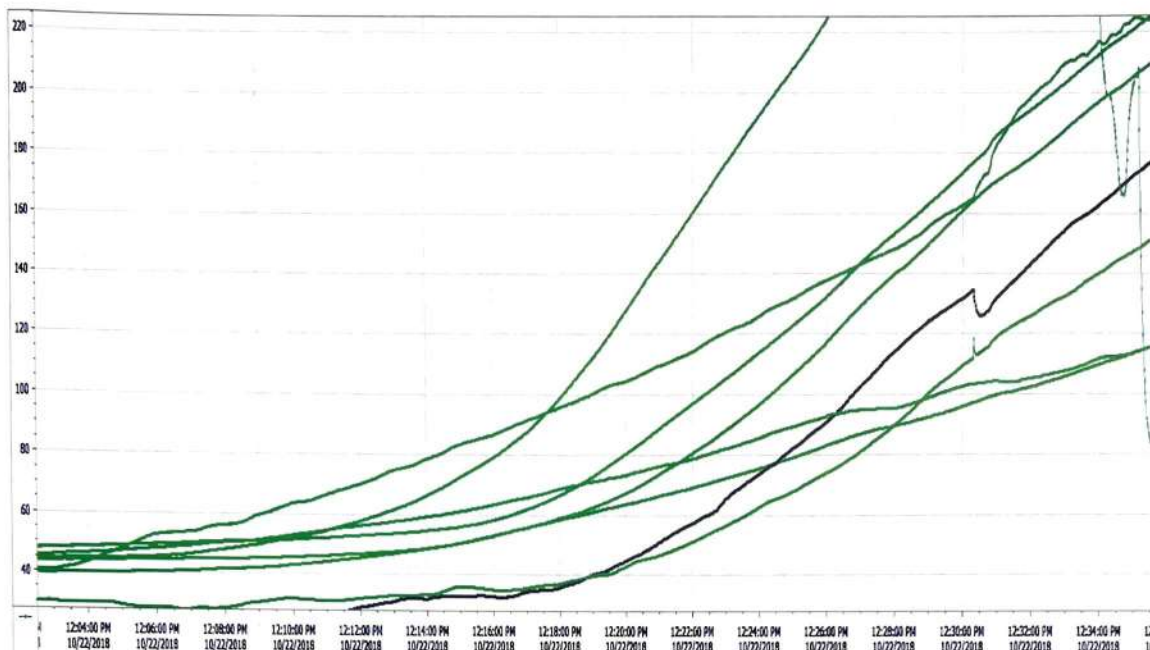
Figure 6: Thermocouple graphs used for obtaining unexposed surface temperature of steel double door assembly (TC1 to TC8) for 30 min duration of test

A positioning diagram, figure 8, for thermocouples placed on the unexposed surface of the double door has been provided in appendix 3. Graph showing unexposed surface temperature rise on the double door can be seen in appendix 2, figure 5.

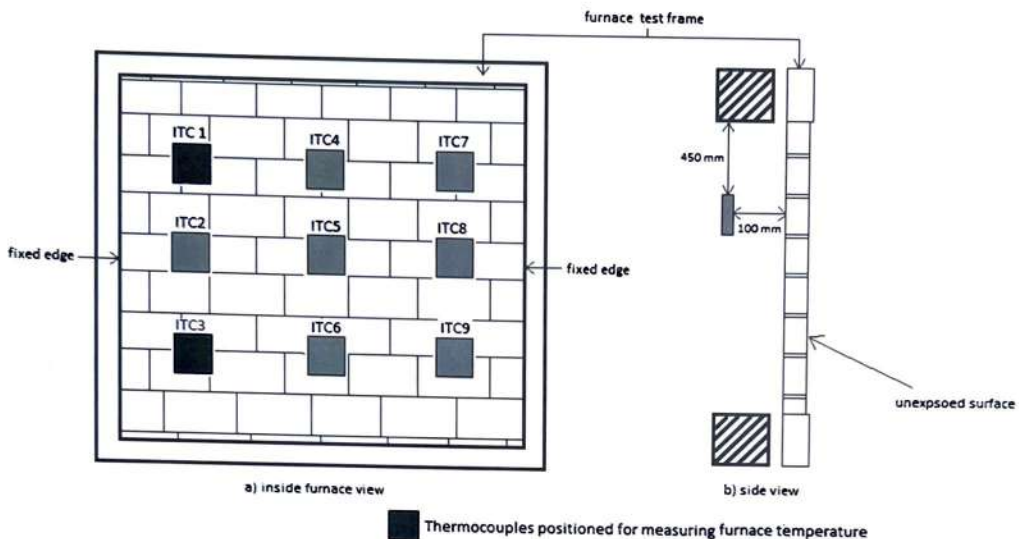
Figure 7: Front view of furnace showing positions of furnace internal thermocouple

Nine internal K type thermocouples, protected using sealed tubes specified in clause 5.1 of ANSI/UL 10C-2009, were distributed evenly for measurement of internal temperature of the furnace. The junctions of the thermocouples were located 152 mm away from the exposed surface of the test assembly. A positioning diagram, figure 7, for the internal thermocouples has been provided in appendix 3.

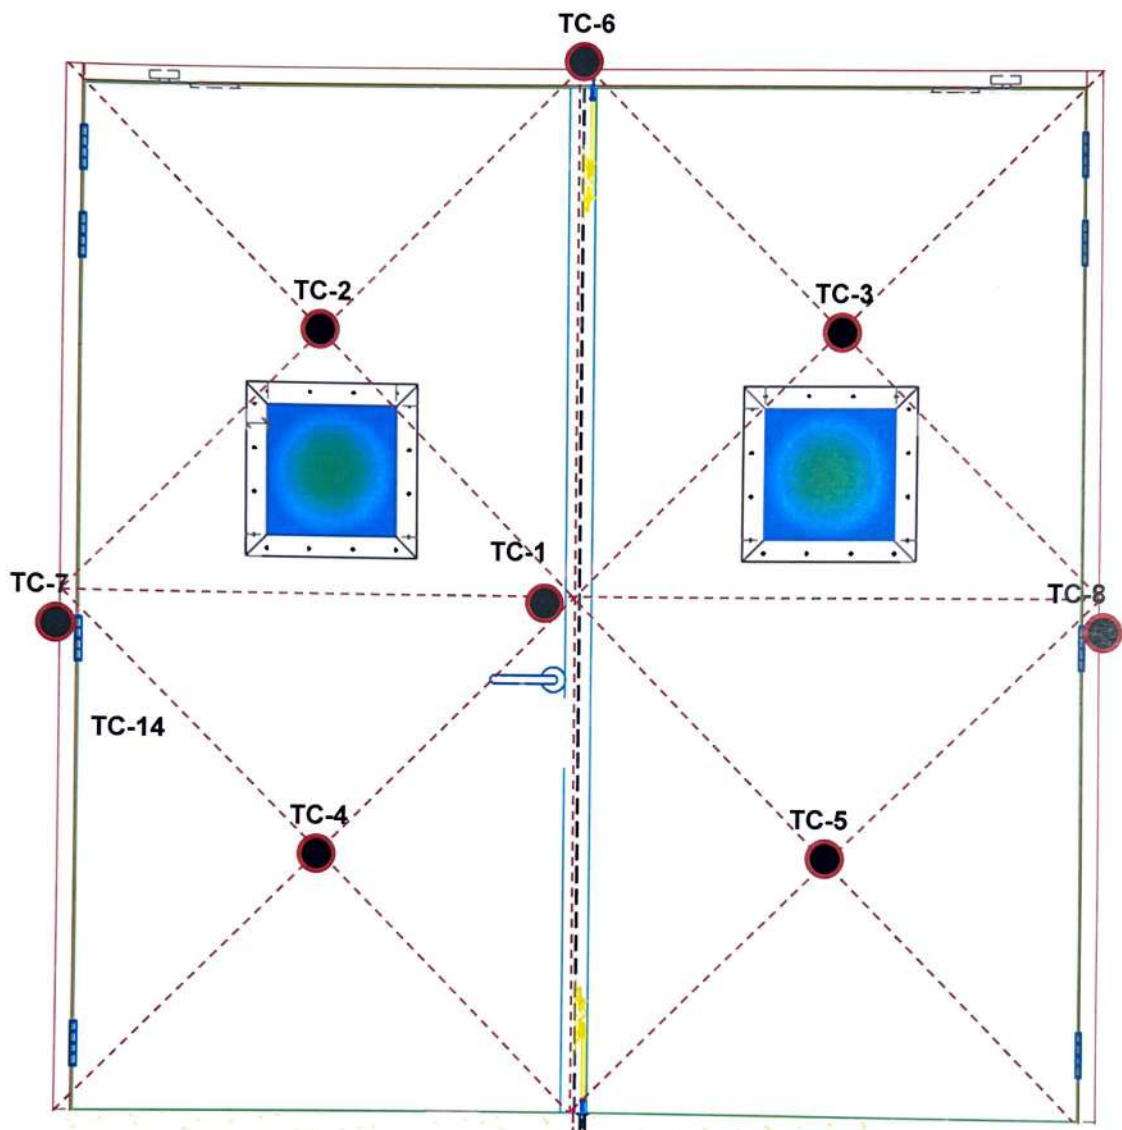
Figure 8: Positioning of thermocouples used to determine unexposed surface of the steel double door.

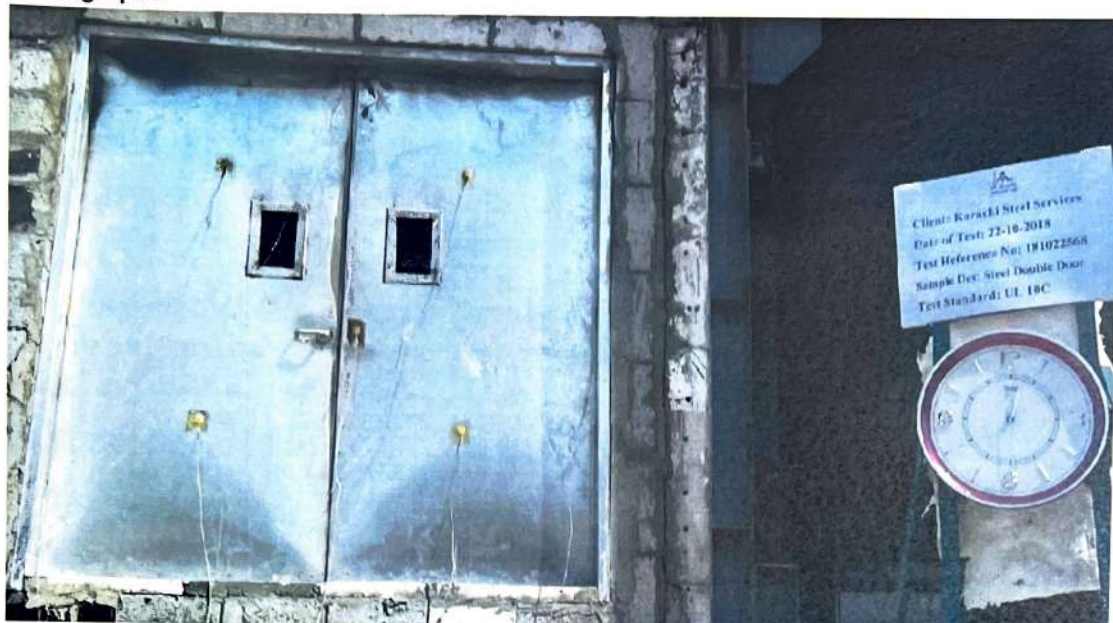
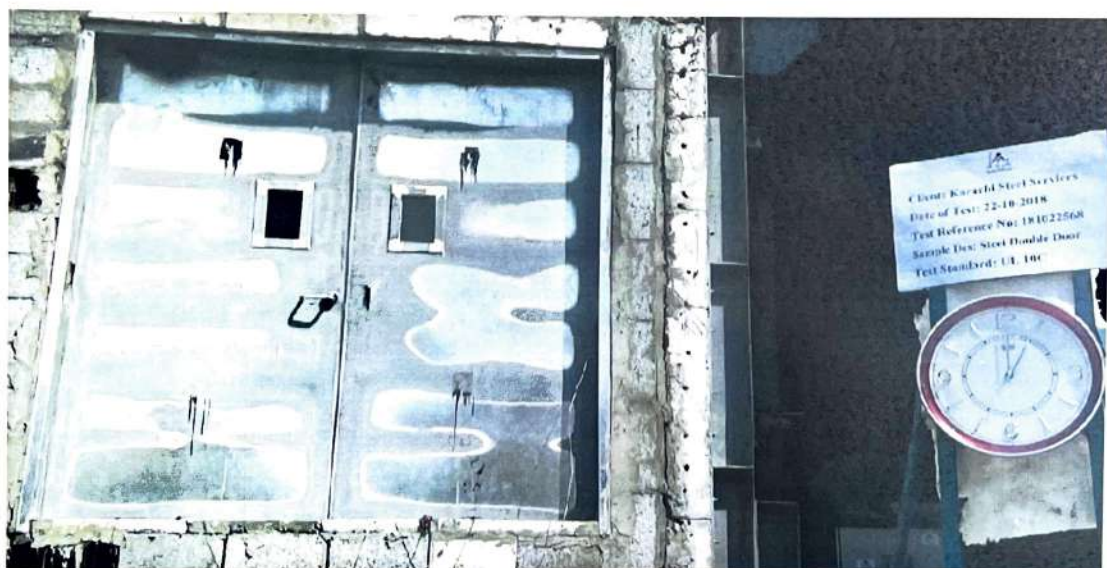
Specimen after 30mins of testing

Specimen after 60mins of testing

Figure 9.1: Unexposed side of specimen during exposure to fire

Time [min]	Observation on unexposed side of specimen during fire endurance and hose stream test
<b>OBSERVATIONS DURING FIRE ENDURANCE TEST:</b>	
0	Commencement of Test.
6	Light smoke escaping from in between leaves at meeting stile top edge.
13	Discoloration of both leaf skins observed at top horizontal edge and slight outwards deflection observed along top horizontal edge of both leaves.
26	Slight outwards deflection observed at astragal on meeting stile top edge, Charring observed at left horizontal and vertical leaf edges of specimen.
30	Further outwards deflection observed at astragal on meeting stile top edge.
31	Deformation of both leaf skins at various locations at top portion of specimen.
35	Discoloration and formation of dark patches along left and right vertical edges of left and right leaf, respectively.
50	Light smoke observed escaping from right vertical edge of right leaf from in between frame and leaf.

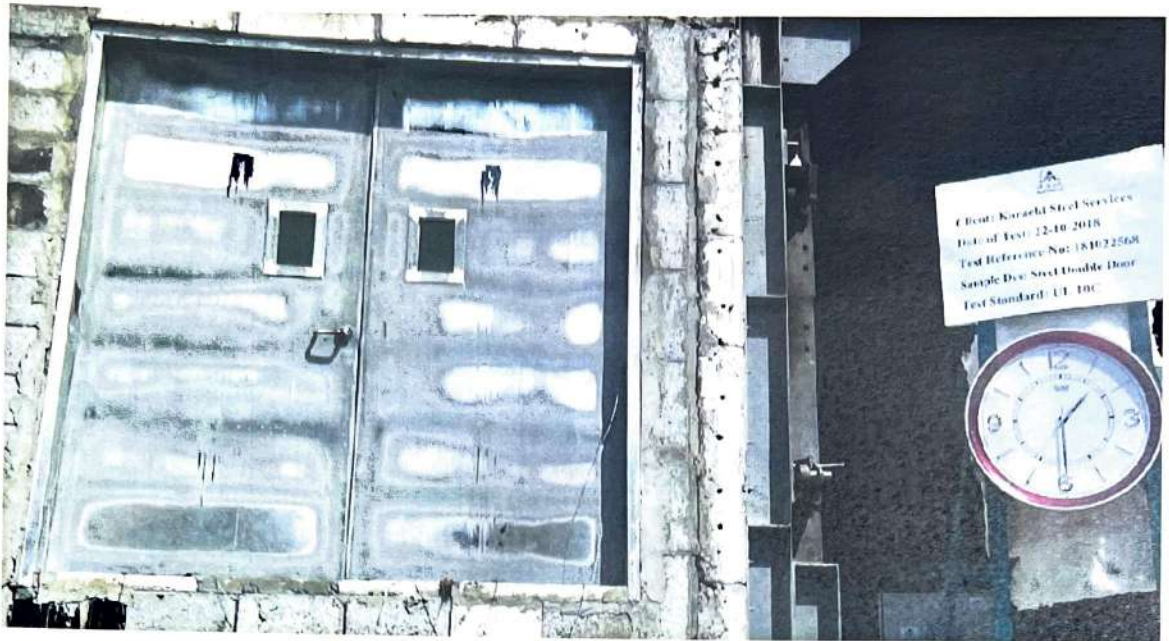
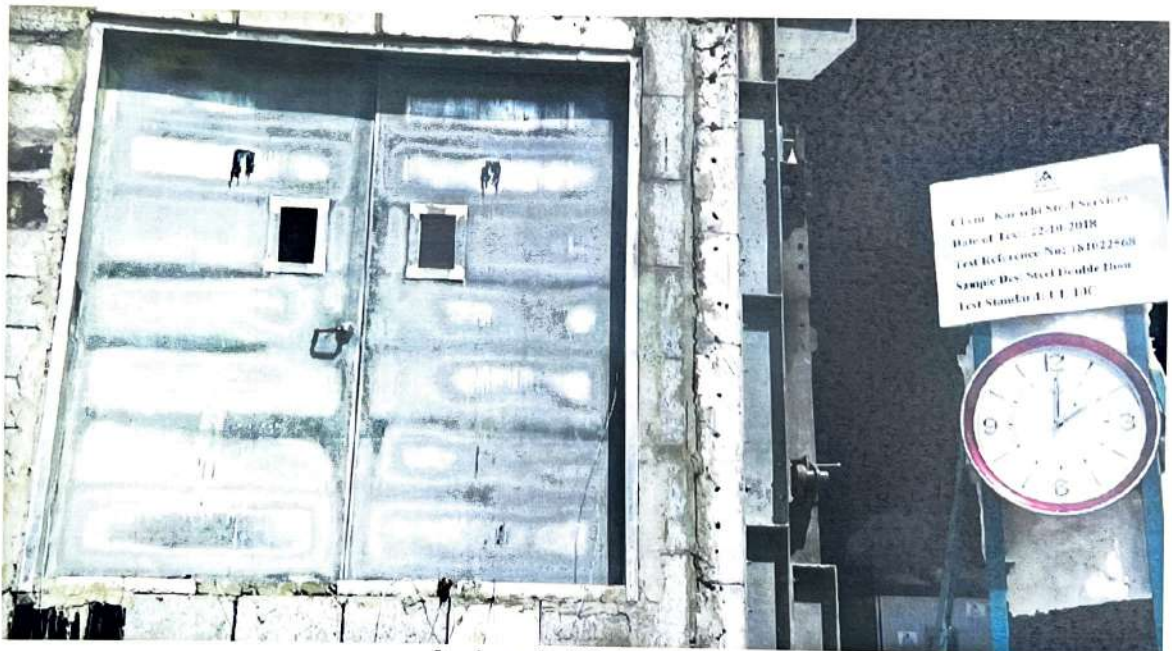
Specimen after 90mins of testing

Specimen after 120mins of testing

Figure 9.2: Unexposed side of specimen during exposure to fire

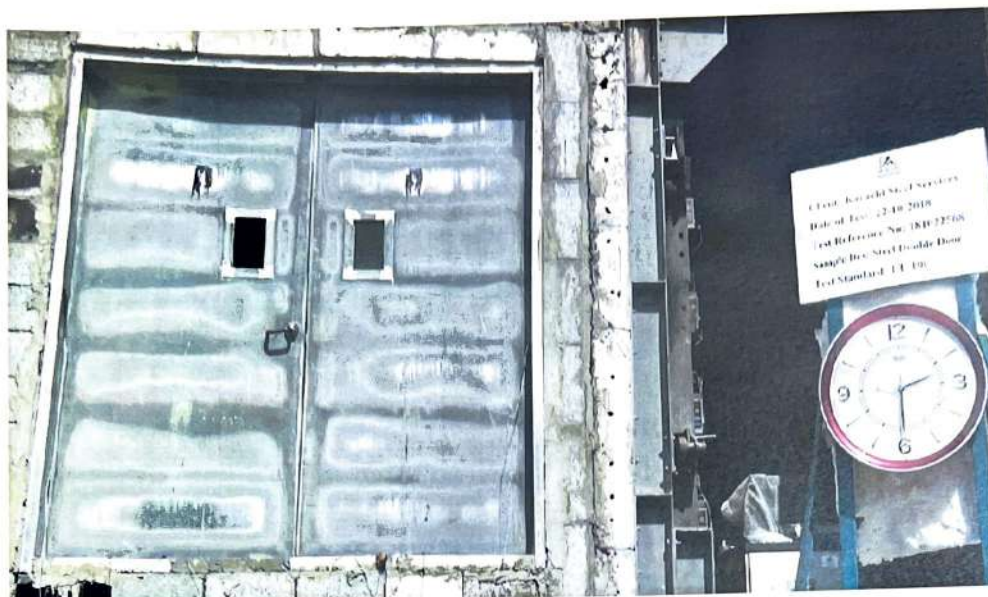
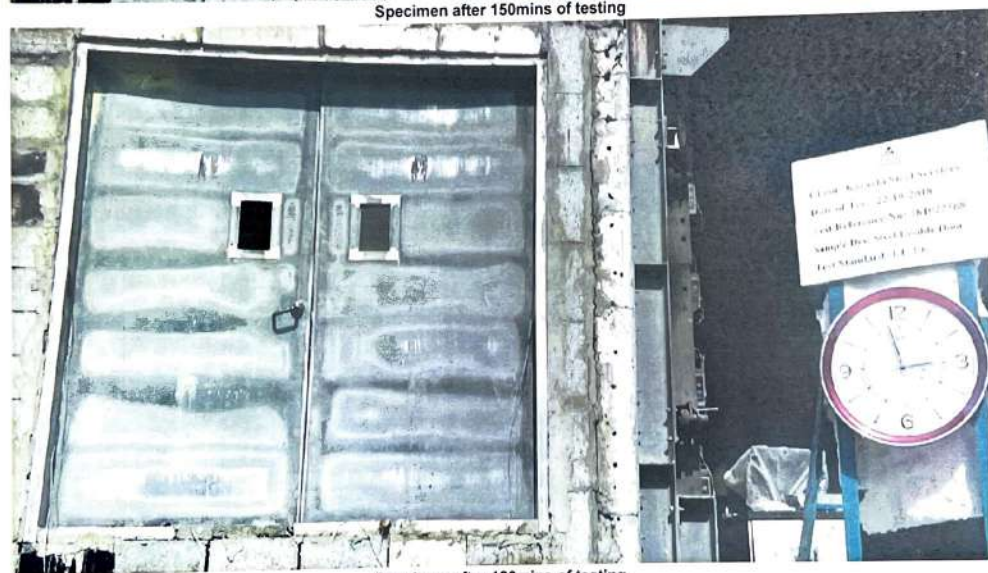
Figure 9.3: Unexposed side of specimen during exposure to fire

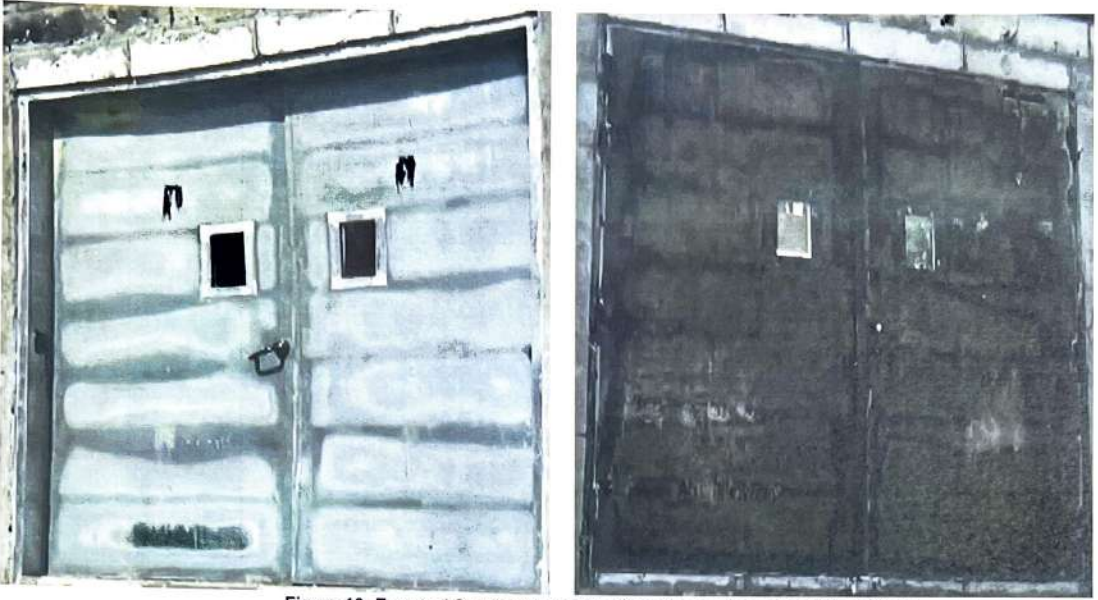
Figure 10: Exposed & unexposed side of specimen after completion of test

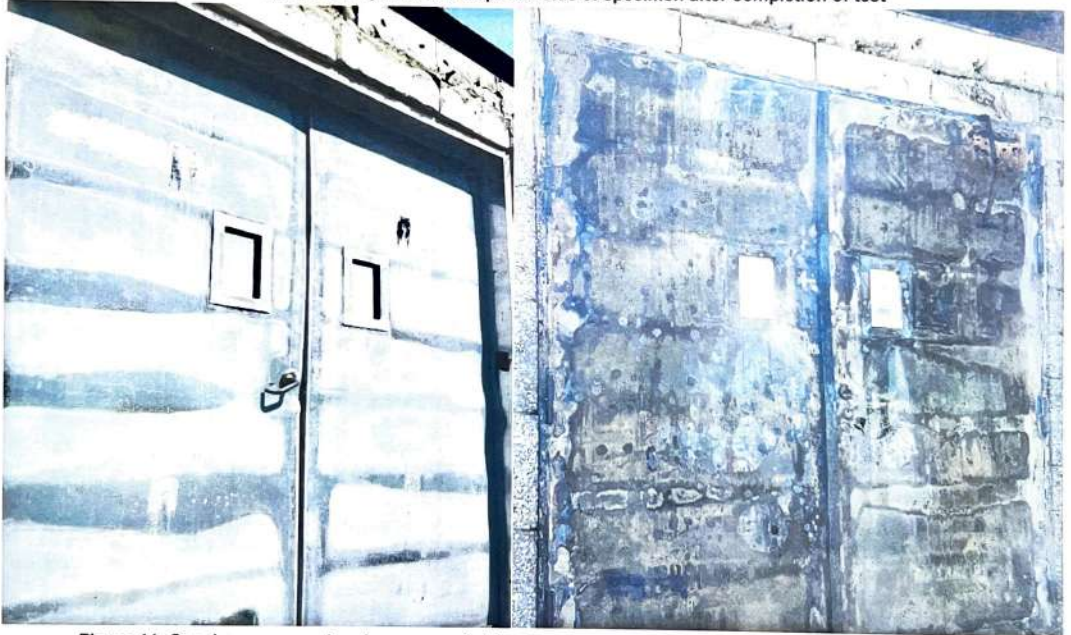
Figure 11: Specimen exposed and unexposed sides immediately after being subjected to hose stream test

2.	There was no through hole or gap formed during or after the hose stream test.
3.	Movement at the edges or along perimeter of door frame and leaves or at the meeting stiles was not observed. Door frames remained fastened to the wall on all sides and no openings developed.

4.	No dislodging of vision panel or crack or breakage in glass was observed. The glazing assembly was not loosened from its fastenings. Separation of glass from frame to create openings was not observed.

5.	There was no deterioration, dislodging or separation of astragal at meeting stile. Separation of astragal in direction parallel to plane of doors more than 19.1 mm did not occur.
